Tongass National Forest, Supervisor's Office | March 2021

Tongass National Forest Fish Passage at Road-Stream Crossings Status

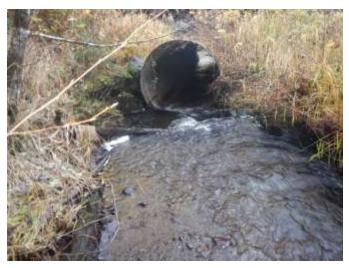
Steelhead Creek RD 2000440 MP 0.130 pre-replacement

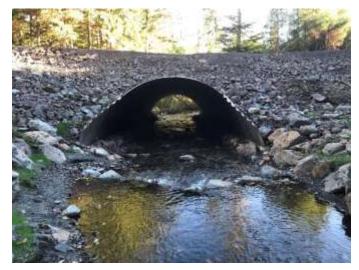
Steelhead Creek RD 2000440 MP 0.130 post-replacement

Between 1998 and 2020, the Tongass has replaced, retrofitted, or removed approximately 648 crossings that were not previously meeting passage standards. Replaced crossings follow a stream simulation design by mimicking the natural channel. The estimated cost of 1998-2020 remediation adjusted to 2020 dollars is \$25.4 million. The Forest has been working with partners in replacement prioritization efforts. RED crossings are prioritized for replacement based on:
